# Preservation of historical evidence in parks as the structure and function of the park changes. Kemeri park reconstruction example in Latvia

Natalija Nitavska, professor, Dr. Arch.

Interreg V-A Latvia – Lithuania Programme 2014-2020

NovelForHeritage LLI-444

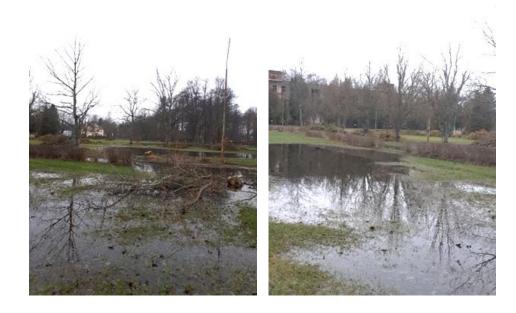
Situation in Ķemeri Park territory at the end of November 2019 (author's photo)

non-functioning drainage system, compacted and wet ground, high groundwater level, overgrown and clogged drainage ditches and culverts, reduction of bulging water capacity and clogging of the bed

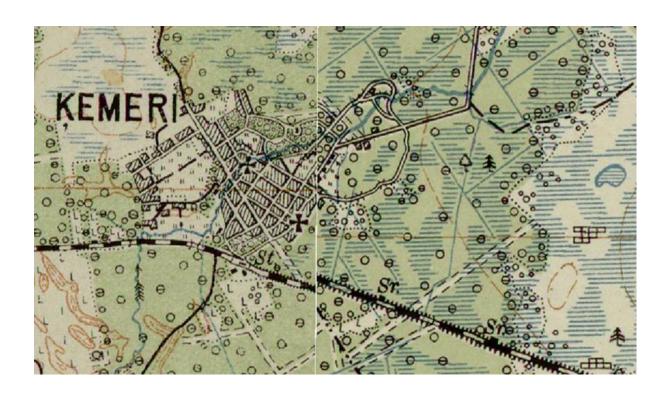
Ķemeri plan with visible drainage engraving network (Latvijas topogrāfiskā S.a.)

Map of Kemeri of the USSR (map of the USSR topo)
